Assessment Of Energy Saving Opportunities For

Little Neston Methodist Church

This report presents the results of a CMEE (Carbon Management Energy Efficiency) site survey of the Methodist Church in Little Neston carried out by Malcolm Hanna of AECOM. The agreed objectives of the wider CMEE project is to undertake audits of 12 churches to identify energy saving opportunities and to produce a short, site specific report. The 12 reports are to be used to prepare a 'How to Guide' which will be distributed to all Methodist Churches to help them prioritise energy saving actions at their sites using real case examples.

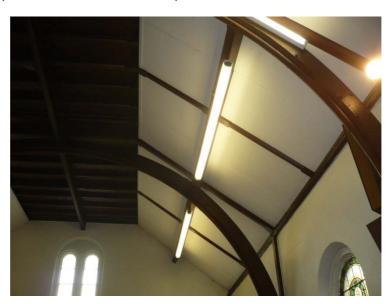
There are currently 16no 8ft T12 fluorescent lamps illuminating the Church. These units are old and inefficient. From an energy efficiency perspective it is recommended that these units are replaced with more efficient alternatives. However it can be seen above that this opportunity represents an extremely long payback on investment. This is due to the fact that the church is used for such short periods of time. For this calculation we have estimated an average across the year of around 4-5 hours per week.

In reality this opportunity would probably be taken when the lights require replacement due to age or condition. In order to replace these units the whole fitting will need to be changed and if this is to be carried it is recommended that high frequency T5 fittings should be specified. There is an additional option of incorporating occupancy and daylight (Lux) control at this point, however due to the relatively short operating hours of the lights and as we understand it, the tight control for the specific service times these additional controls may not be provide sufficient benefit. This point should be further considered if this element is implemented, particularly around lighting control, as the church has good sources of natural daylight.

It is suggested that these T12 fittings would be replaced by twin 28W T5 units, 16 fittings in all. This would need to be confirmed by a lighting designer. The energy savings relate to the reduced control gear loses of the fittings, for the existing T12 units these are around 40%, for new high frequency units these are around 5-10%. The new fittings also provide the opportunity to reduce the rating of the installed units, from the existing 125W per fitting to 56W per fitting. Finally the inclusion of integrated controls for occupancy and daylight dimming control could add a further saving.
