# Assessment Of Energy Saving Opportunities For Bromborough Methodist Church

This report presents the results of a CMEE (Carbon Management Energy Efficiency) site survey of the Methodist Church in Bromborough carried out by Malcolm Hanna of AECOM. The agreed objectives of the wider CMEE project is to undertake audits of 12 churches to identify energy saving opportunities and to produce a short, site specific report. The 12 reports are to be used to prepare a 'How To Guide' which will be distributed to all Methodist Churches to help them prioritise energy saving actions at their sites using real case examples.

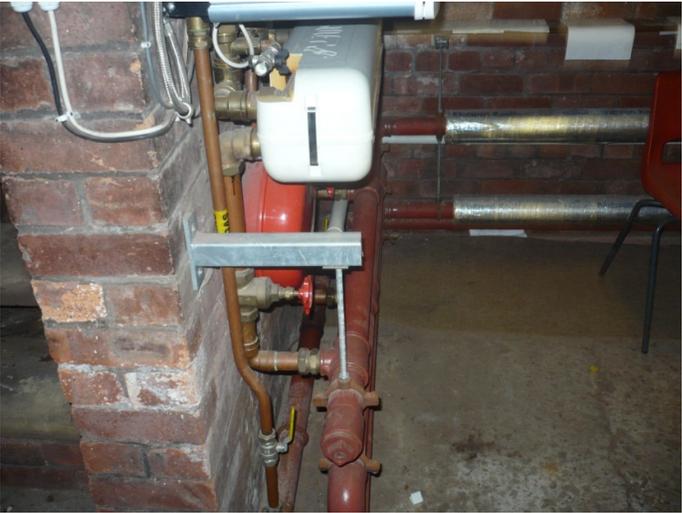
<b>Priority no. 4</b>	<b>Insulate pipes and valves in boiler room</b>			
<b>Cost Saving £/yr or £k/yr</b>	<b>CO<sub>2</sub> Savings tonnes/yr</b>	<b>Energy Savings kWh/year</b>	<b>Cost £ or £k</b>	<b>Payback Years</b>
£157	0.94	5,131	£200	1.3
<b>Detail</b>	<p>It was found during the visit that there is a significant amount of pipework and valves currently un-insulated in the boiler room area. Insulation has been purchased but not yet fitted due to time availability. It is recommended that this is carried out as soon as time is available.</p>

<p>Capital costs have been included above. In order to give a comparative view of this opportunity compared with others. It has been assumed that half a day of labour would be required for this task. However it is appreciated that much of the capital costs has already been met.</p>

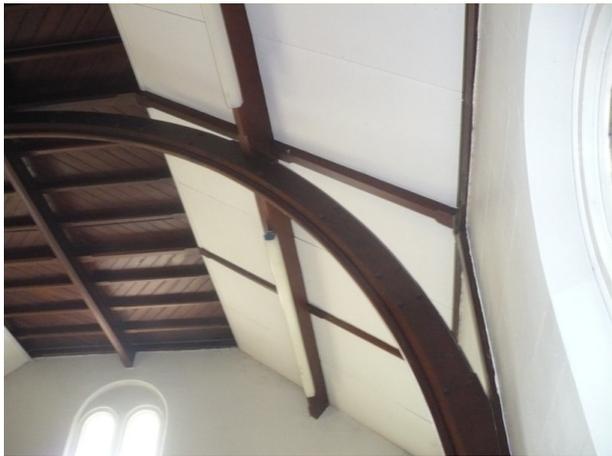
<b>Priority no. 6</b>	<b>Insulate the Church Hall roof area.</b>			
<b>Cost Saving £/yr or £k/yr</b>	<b>CO<sub>2</sub> Savings tonnes/yr</b>	<b>Energy Savings kWh/year</b>	<b>Cost £ or £k</b>	<b>Payback Years</b>
£90	0.54	2,948	£924	10
<b>Detail</b>	The Church Hall roof is currently un-insulated. This was confirmed by contractors working in this area on the day of the visit. The Church Hall is heated and would benefit from insulation of the roof space where practically possible. It is therefore recommended that the roof is insulated with mineral and rock wool applied between wooden frame members and rafters. This has good thermal insulation properties and can be installed by a general builder, measuring and cutting skills are required to a depth of 150mm.

<p>The Carbon Trust guide CTL064, How to implement roof insulation indicates that up to 25% of the heat lost from a building's fabric is lost through the roof and that the application of insulation to un-insulated roofs can reduce this loss by up to 90%. For the purpose of this report we have utilised a figure of 45% as only a proportion of the existing roof area could be practically insulated.</p>
<b>Risks to business continuity</b>	No significant risks
