# Assessment Of Energy Saving Opportunities For

## Knutsford Methodist Church

This report presents the results of a CMEE (Carbon Management Energy Efficiency) site survey of the Knutsford Methodist Church carried out by Adam Fjaerem of AECOM. The agreed objectives of the wider CMEE project is to undertake audits of 12 churches to identify energy saving opportunities and to produce a short, site specific report. The 12 reports are to be used to prepare a 'How To Guide' which will be distributed to all Methodist Churches to help them prioritise energy saving actions at their sites using real case examples.

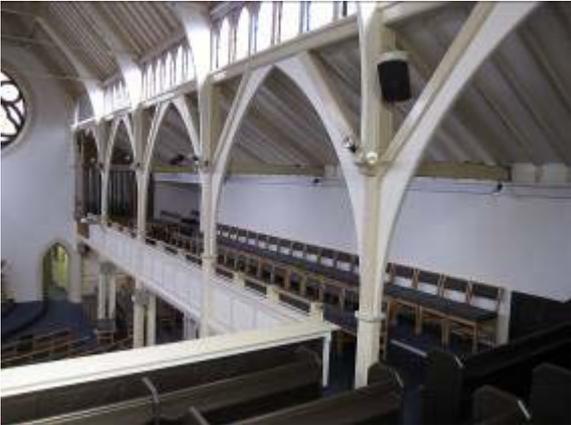
<b>Priority no. 2</b>	<b>Replace lighting on upper balcony</b>			
<b>Cost Saving £/yr</b>	<b>CO<sub>2</sub> Savings tonnes/yr</b>	<b>Energy Savings kWh/year</b>	<b>Cost £</b>	<b>Payback Years</b>
33	0.25	450	97	3
<b>Detail</b>	<p>The church is lit by 30 x 120W tungsten bulbs in spotlight luminaires. Above the new balcony nine of these fittings are installed as single lamps which are inappropriate for this location as they provide a great deal of heat onto the congregation's heads.</p>

<p>It is suggested that these nine lamps are replaced with a 20W CFL equivalent. These would not have sufficient throw of light to replace the remaining spot lights but would provide sufficient light to light the upper balcony efficiently</p>

and in the process provide a more comfortable environment for people sitting upstairs.
<b>Risks</b>	No risk, but the site should not use these lamps to replace the 'true' spotlights as the 'throw' of light would be insufficient.

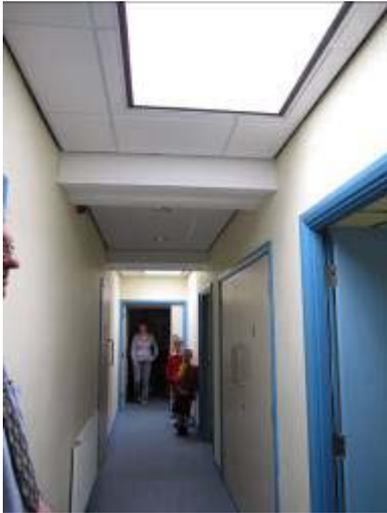
<b>Priority no. 4</b>	<b>Daylight controls in corridors</b>			
<b>Cost Saving £/yr</b>	<b>CO<sub>2</sub> Savings tonnes/yr</b>	<b>Energy Savings kWh/year</b>	<b>Cost £</b>	<b>Payback Years</b>
3	0	45	192	59
<b>Detail</b>	<p>On the day of the audit the upstairs corridor lighting in the community hall was on despite the amount of natural light coming through the roof lights.</p> <p>It is recommended that daylight controls are added to these circuits to turn these lights off when natural lighting levels are sufficient.</p>

<b>Risks</b>	No risk, however, a 10 minute override should be set up on the controls to hold the lights on or off should the day light be temporarily reduced i.e. a cloud passing over the sun.
