GUIDE TO ENERGY RETROFIT OF TRADITIONAL BUILDINGS

HISTORIC
ENVIRONMENT
SCOTLAND

Historic Environment Scotland Guide to Energy Retrofit of Traditional Buildings © Historic Environment Scotland 2021

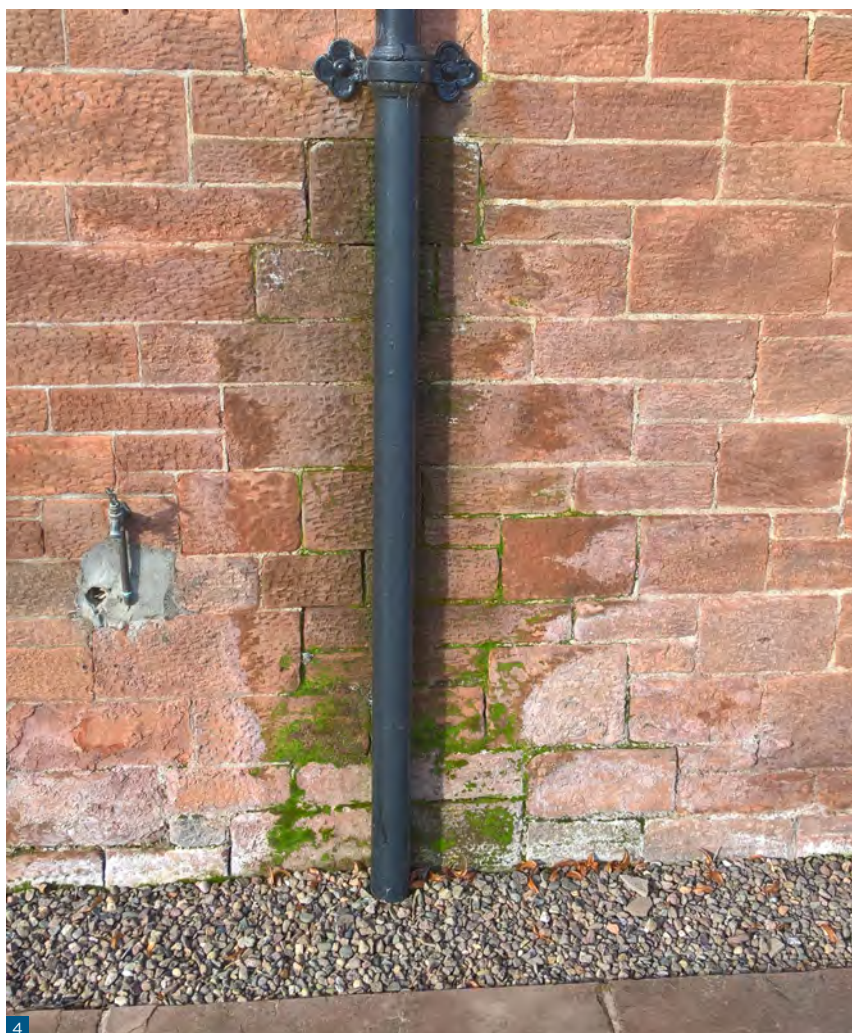
Figure 4: All buildings should be well maintained, and any defects should be repaired before any retrofit work is undertaken. This downpipe has been blocked for some time and the masonry behind appears to be saturated; this defect should be addressed first before any insulation work.

Proper and regular maintenance of a building is a prerequisite to undertaking energy efficiency improvements in a traditional building. If a building is not watertight, there is little point in making energy efficiency upgrades. If dampness or excess moisture is already present, such upgrades may cause further moisture and damage. An example of defective fabric is shown in figure 4 below, where a blocked downpipe is saturating the wall, allowing plant growth. Insulation here would be rendered ineffectual. The blocked downpipe must be repaired, and the wall dried out prior to any such work. Furthermore, heat loss through a damp masonry wall is higher than from a dry wall. Details of appropriate maintenance measures in traditional buildings are given in a number of HES publications, including [Short Guide 9 'Maintaining Your Home'](#) and [Short Guide 11 'Climate Change Adaptation in Traditional Buildings'](#).

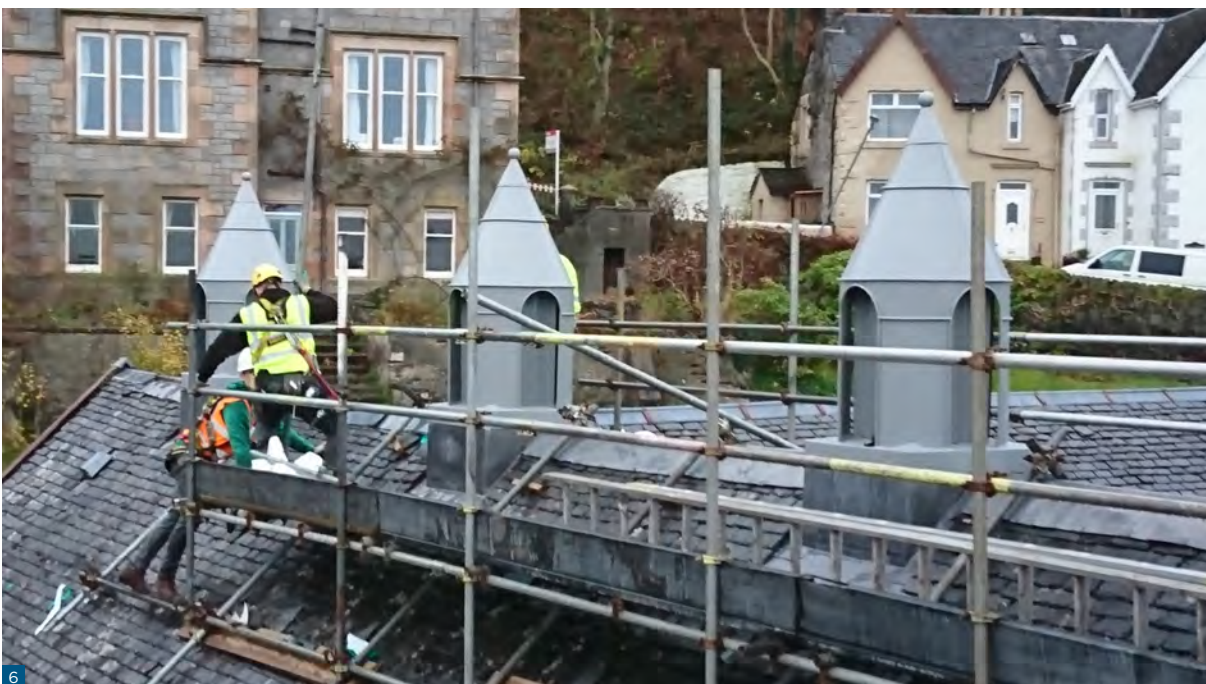
Figure 6: Reinstated ridge level vents at a former school in Oban. Image © Rockfield Centre

Older buildings were mostly ventilated by passive means, normally through modest air infiltration through windows, doors and up and out via the chimney flues. The design of older buildings allowed what is called 'cross ventilation', where air was admitted on one side and released on the other. Many public buildings, such as halls and theatres, had sophisticated passive ventilation systems using roof level vents and draught-free air entry. In recent years, these have been removed or blocked and, as a result, overheating and discomfort often occurs. In a recent project, HES supported the reinstatement of roof level ventilators on a former school in Oban as part of a restoration of a passive vent system (figure 6) to investigate traditional ways of ensuring good indoor air quality.

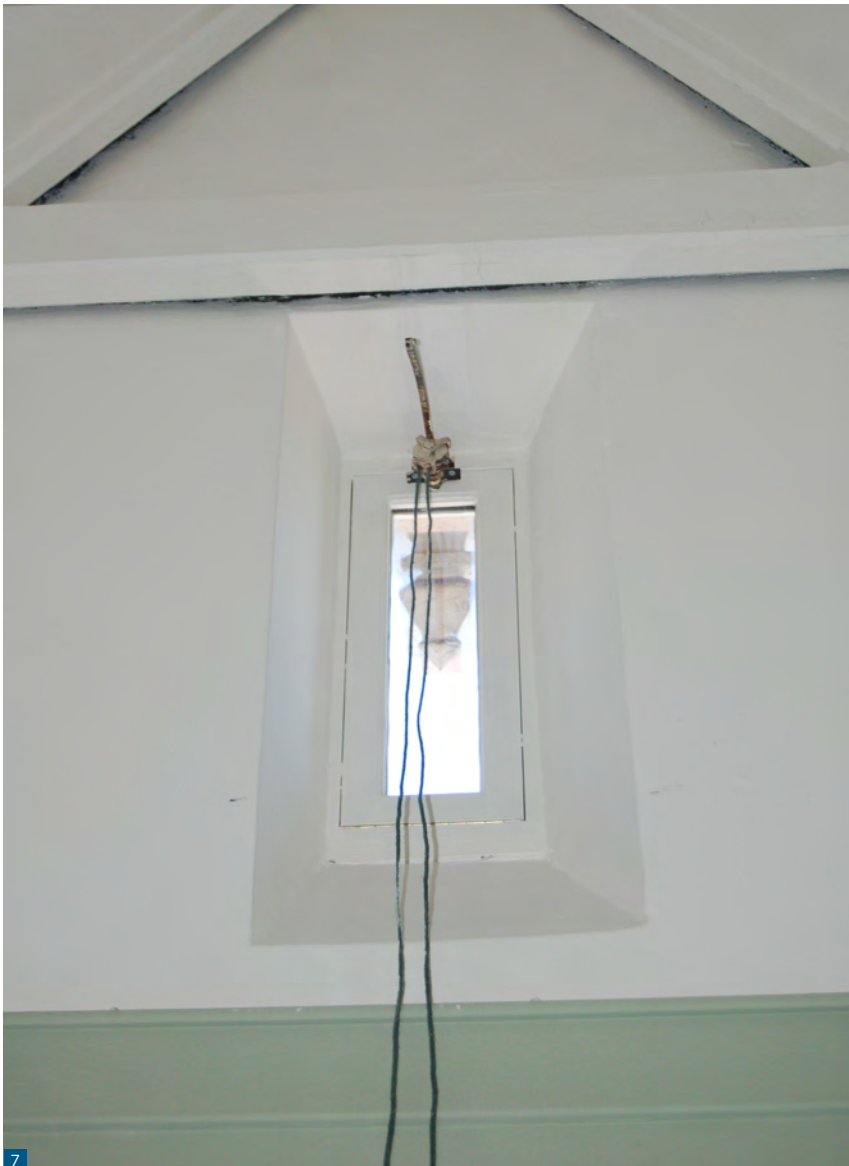
Figure 7: This quarter light has been made to open to allow managed ventilation.

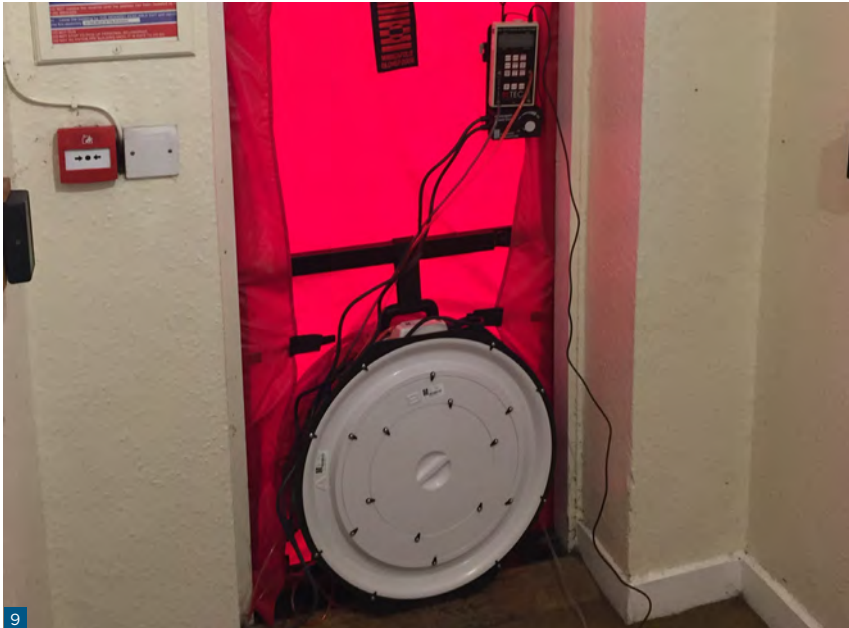
Figure 9: An air pressure test taking place at Holyrood Park Lodge before the interventions.

While having high levels of air tightness is not a direct objective in a HES retrofit, reducing air leakage in and out of the building is clearly necessary. This can be achieved by the combined effects of the various measures - the floor insulation, window and door draught-stripping, wall insulation and the temporary closing of hearths (such as with chimney balloons). Such approach was taken at Holyrood Park Lodge and airtightness testing (figure 9) showed that an improvement of 30% was achieved after the works.

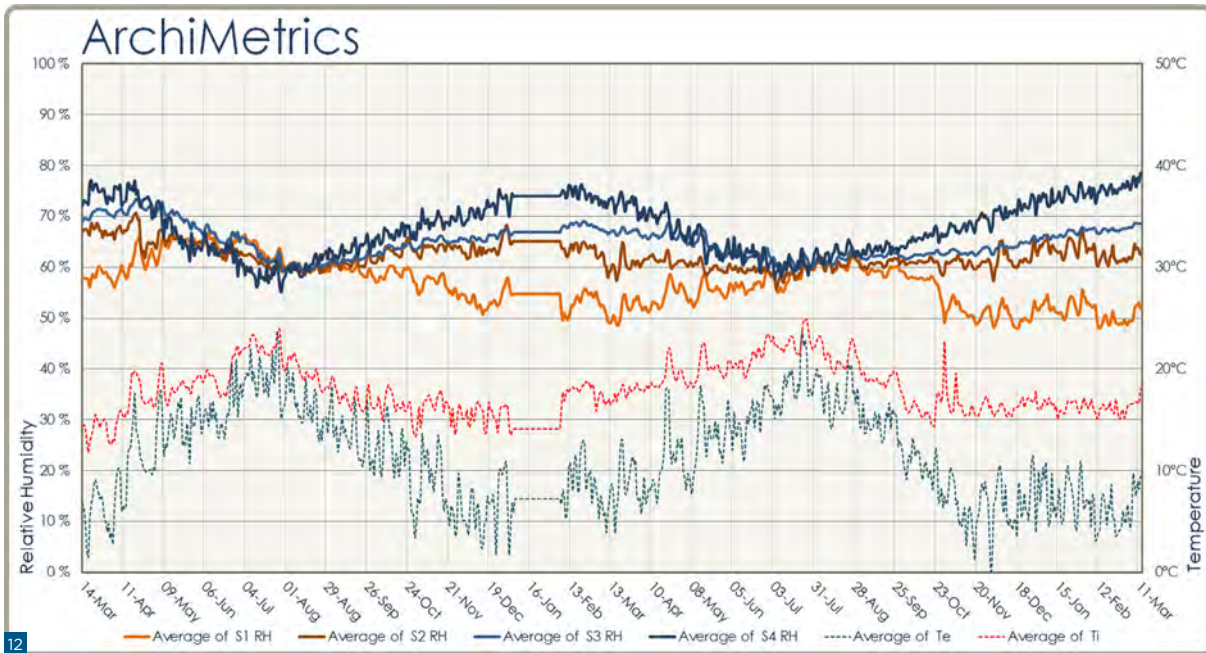
Figure 12: Extensive moisture monitoring from the Holyrood Park Lodge case study has demonstrated the successful use of vapour permeable insulation in traditional buildings. Four combined temperature and RH sensors were placed at various depths of the wall, with S1 being in the insulating cellulose fibre layer and S4 closer to the external wall face. Image © ArchiMetrics

HES refurbishment case studies have supported the use of vapour and capillary active materials to control internal humidity and prevent moisture build up. This is shown through the monitoring of moisture levels in a number of projects. In one of these projects, at Holyrood Park Lodge, relative humidity values varied significantly before the interventions, mainly due to the building being underheated. However, monitoring has shown that, post-refurbishment, the west wall behaves much as traditional walls behave in heated buildings, with a much lower relative humidity level. These relative humidity levels are an improvement to both the internal environment and the wall conditions, showing that the insulation had indeed a positive impact. A representative graph of humidity through the wall section, including within the insulation, is shown in figure 12.

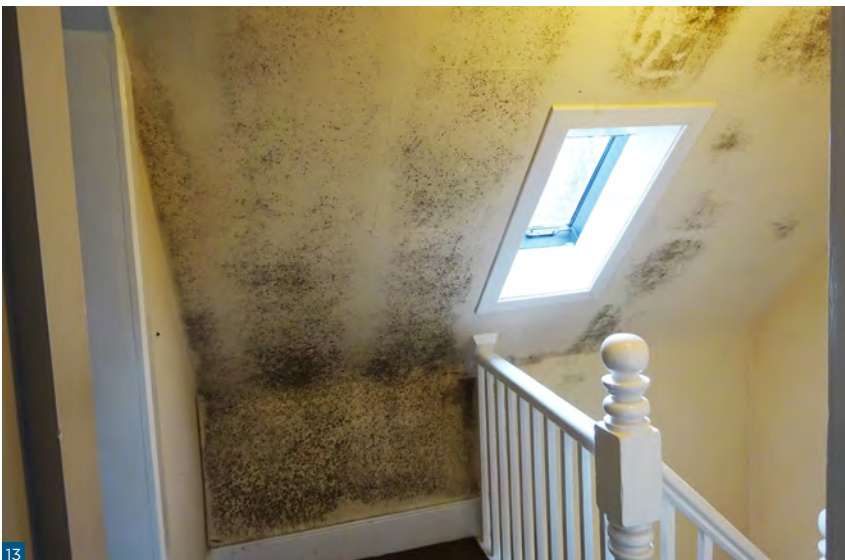
Figure 13: Vapour impermeable materials and a lack of ventilation have led to significant mould growth on internal surfaces in this building.

The wrong materials and inadequate ventilation can lead to condensation and mould growth, as seen in figure 13. Energy efficiency improvements that utilise materials which are impermeable to moisture are less able to buffer humidity and can result in moisture being unable to dissipate from building fabric. If this is combined with the blocking of ventilation pathways, the potential for long term decay of building fabric is considerably increased.

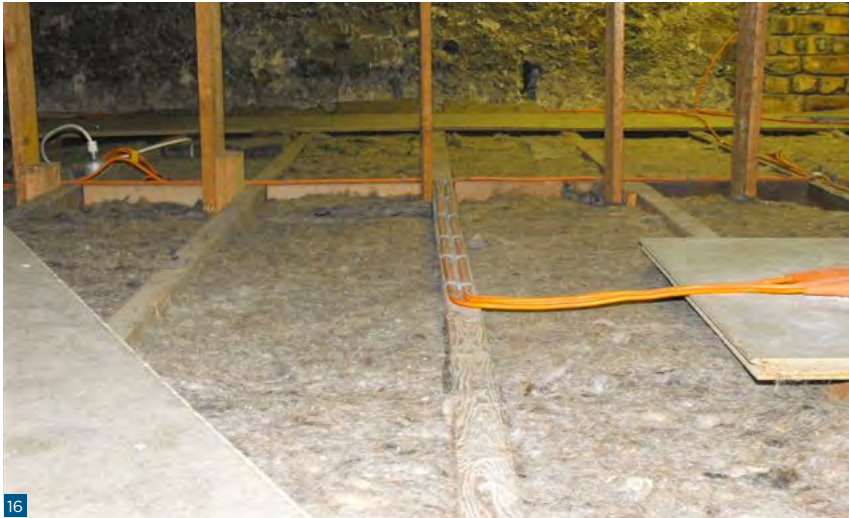
Figure 16: Sheep's wool insulation laid between rafters at Edinburgh Castle. Note the accommodation and fastening of wiring above the insulation.

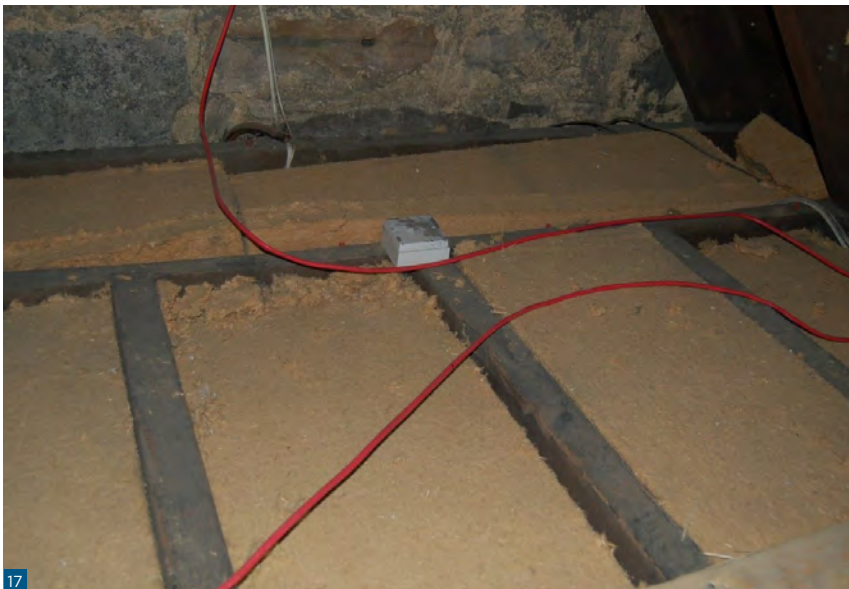
Figure 17: Wood fibre board laid between ceiling joists.

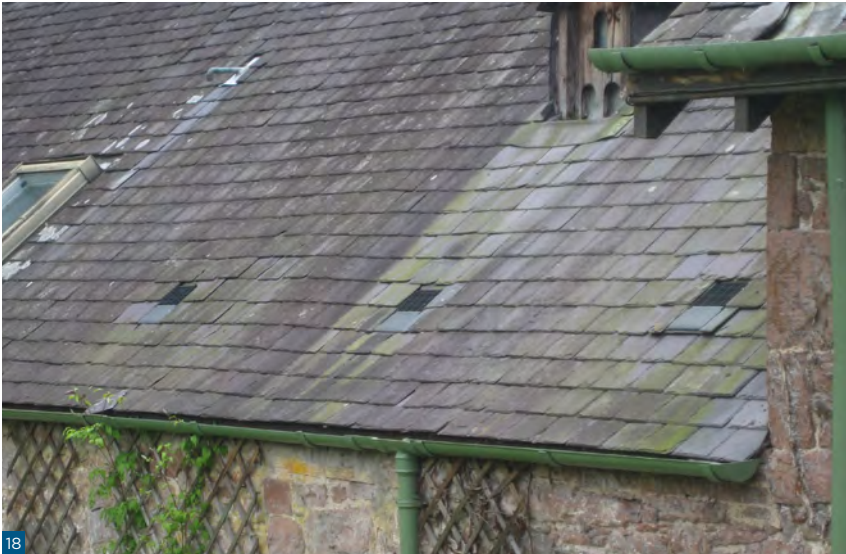
Figure 18: Low profile roof vents on a slate roof following an upgrade to the roof space.

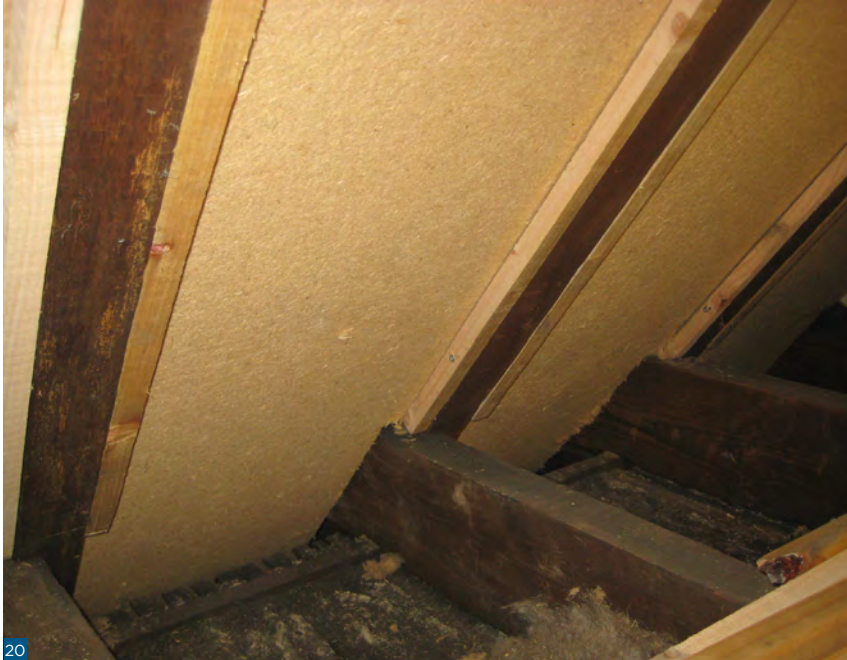
Figure 20: A roof slope insulated with a wood fibreboard insulation between the rafters.

In order to best manage water vapour movement, a vapour permeable material should be used for insulation. For ease of working, a board-based material or semi flexible material, such hemp bats or wood fibre board, might be most suitable (figure 20).

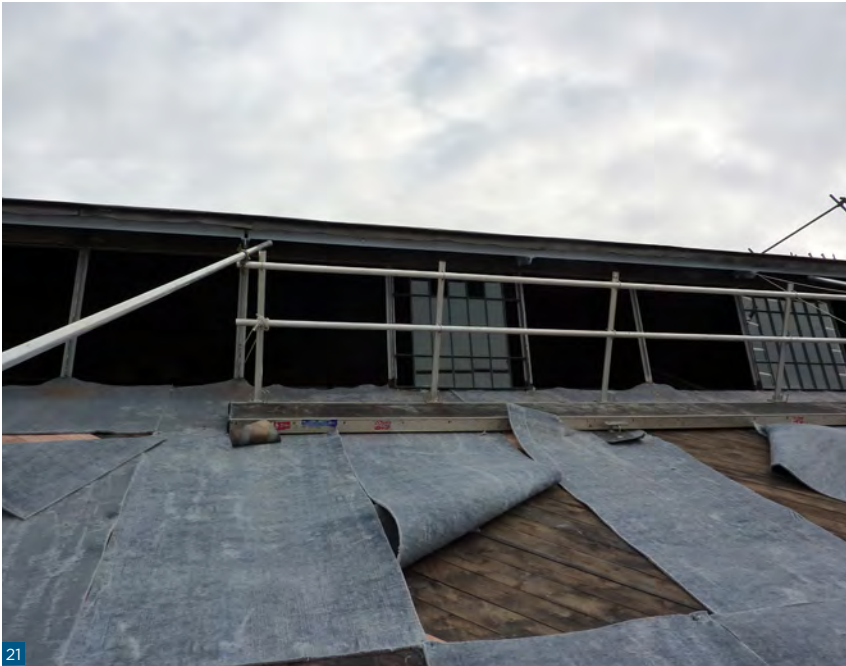
Figure 21: An aerogel insulation blanket laid on top of the sarking.

Some roofs are open to the inside and might be lined. This is occasionally found in workshop space or church buildings. If the roof is being re-slatted, an aerogel blanket laid on top the sarking can also be an option. This gives a good thermal barrier, as well as cushioning the slates (figure 21).

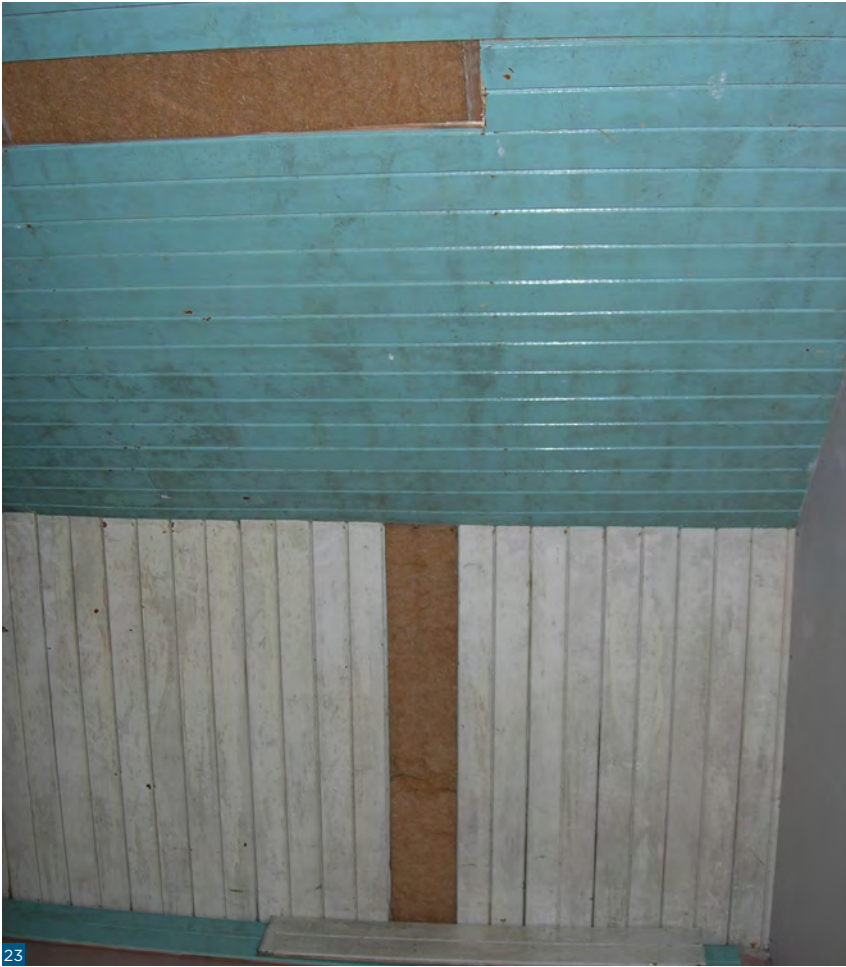
Figure 23: Wood fibre board used behind an existing timber lining on a coom.

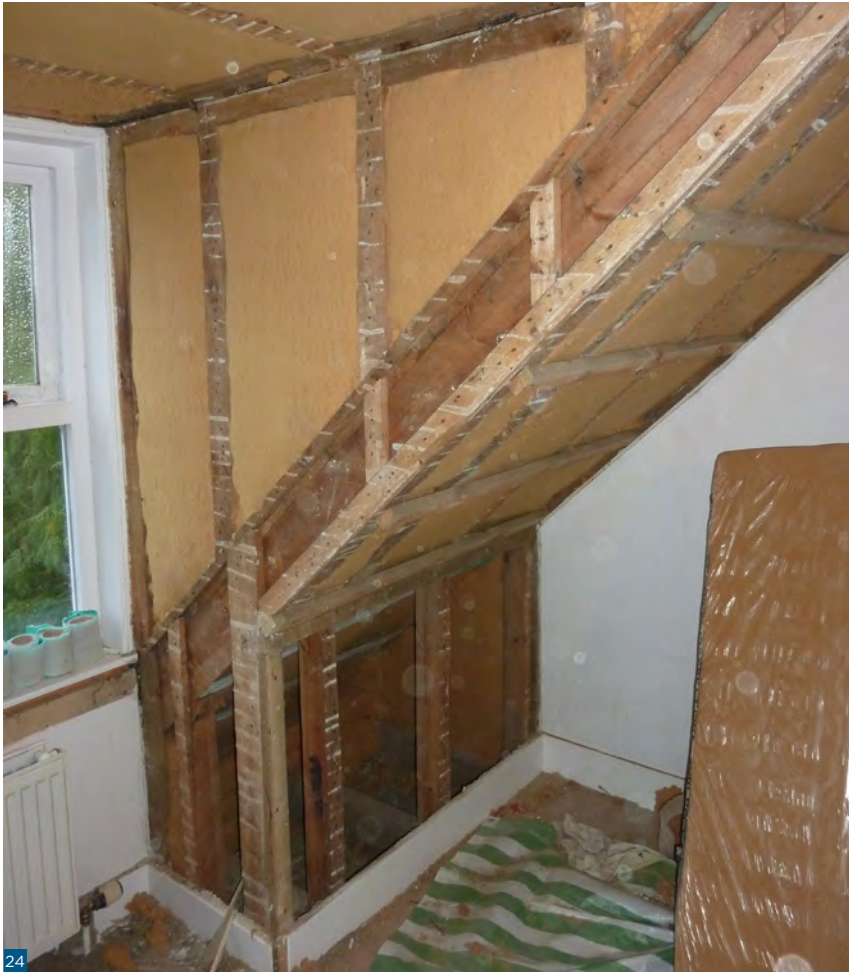
Figure 24: Insulation work to a dormer using wood fibre board.

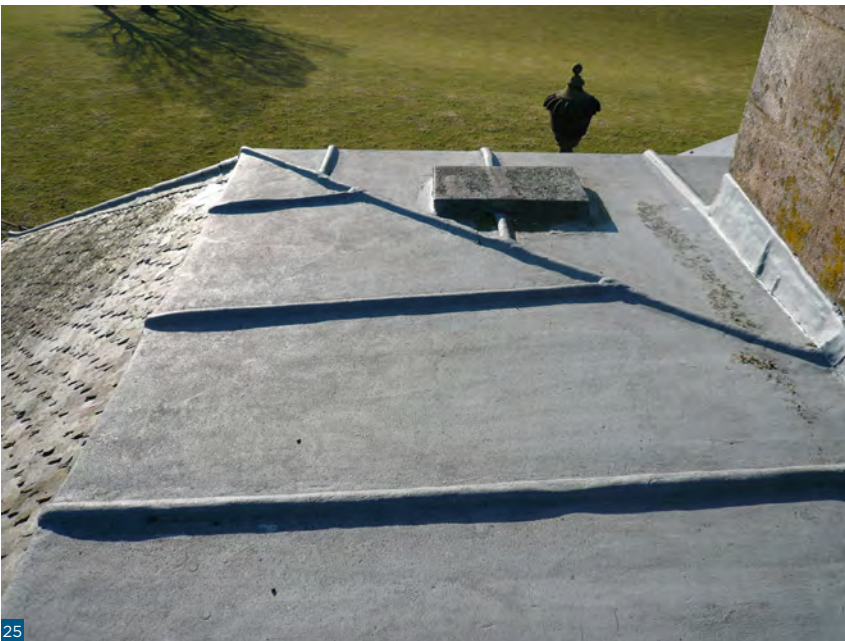
Figure 25: Care is required where a flat roof is covered in lead or other metal not to cause conditions on the underside that lead to corrosion following retrofit.

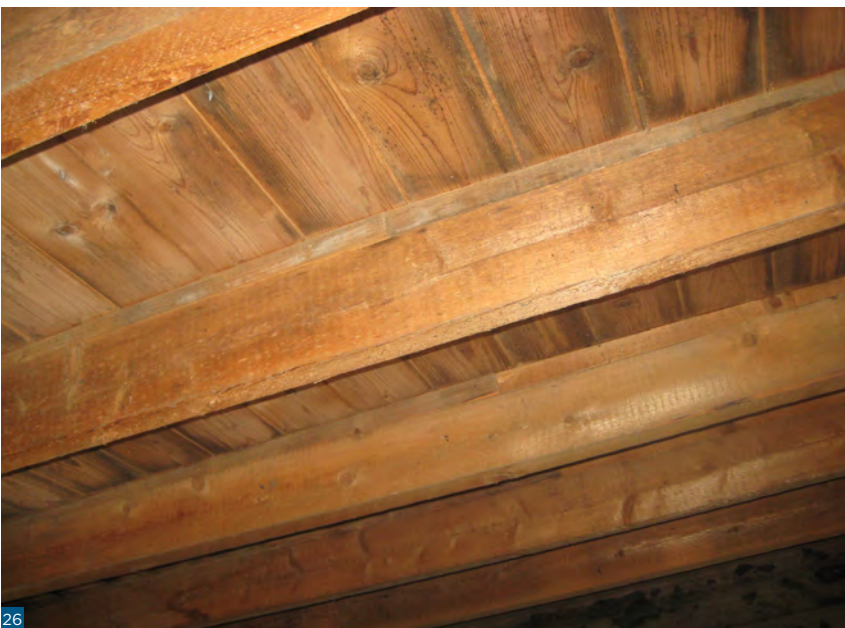
Figure 26: A typical underside of a flat roof.

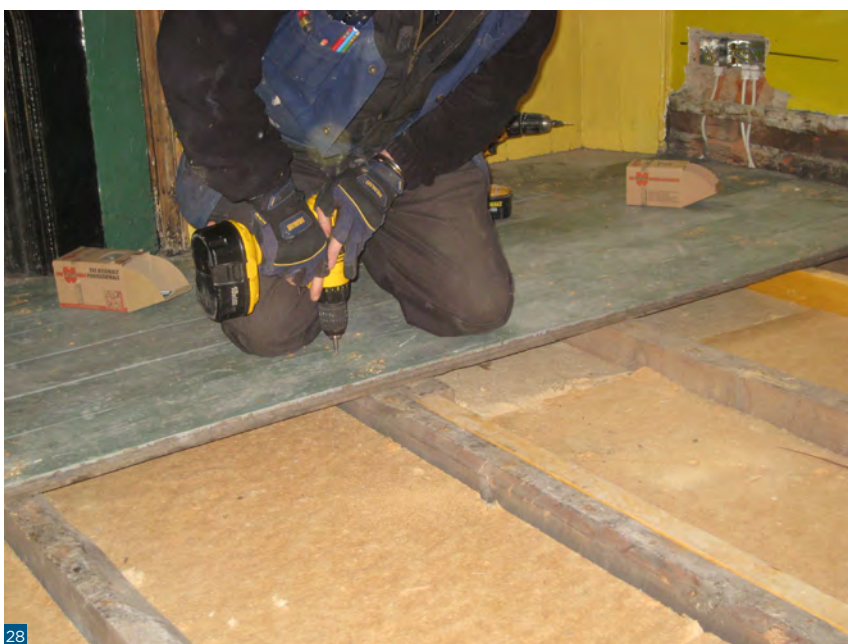
Figure 28: Relaying a timber floor once the insulation is in place.

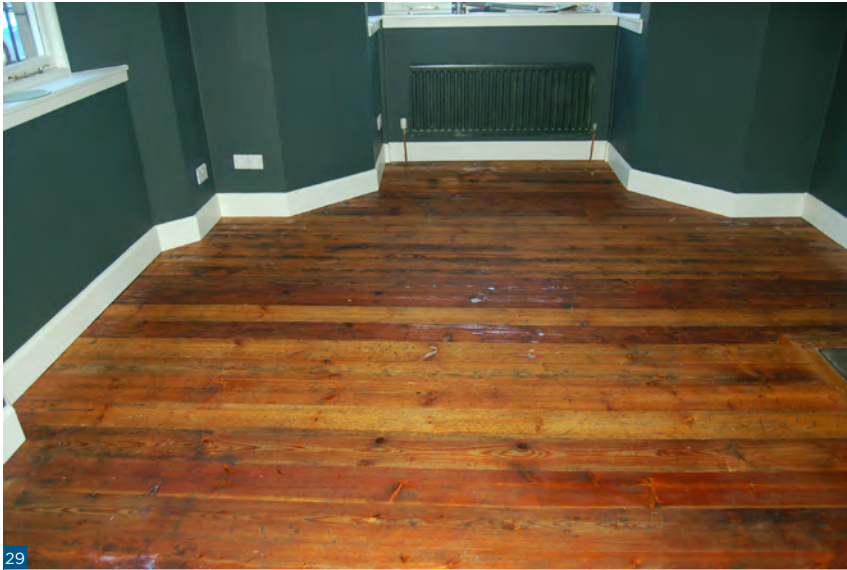
Figure 29: A re-laid floor can be finished to a high standard.

The board should be cut to ensure a snug push fit and the cutting is sometimes best done outside. With a snug fit, sufficient air control is achieved without the use of additional materials. In any event, absolute air tightness is not necessarily needed. The lifted boards are then re-fastened, as shown in figure 28. Older flooring timber is generally of a better quality than new and a good finish can be achieved (figure 29).

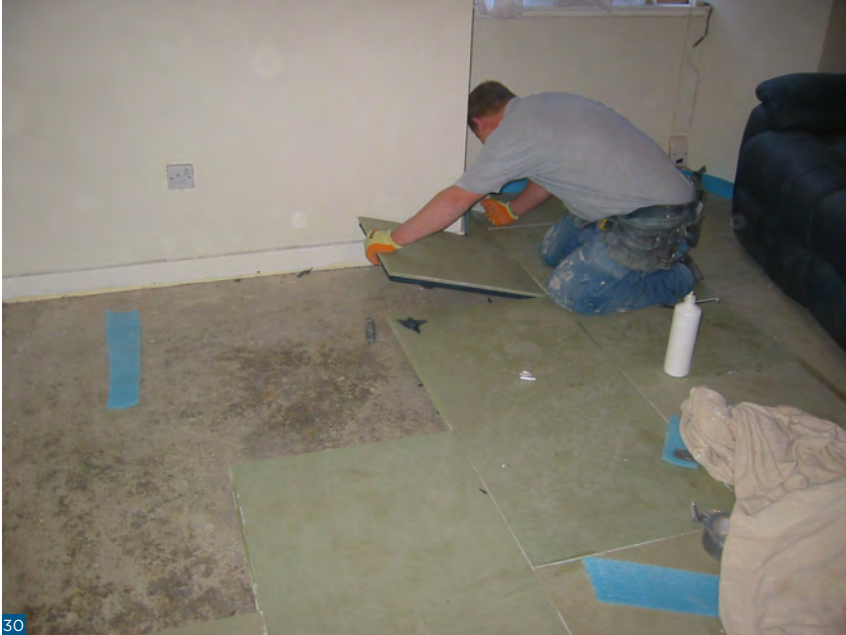
Figure 30: Aerogel board being laid onto a concrete floor.
Image © Changeworks

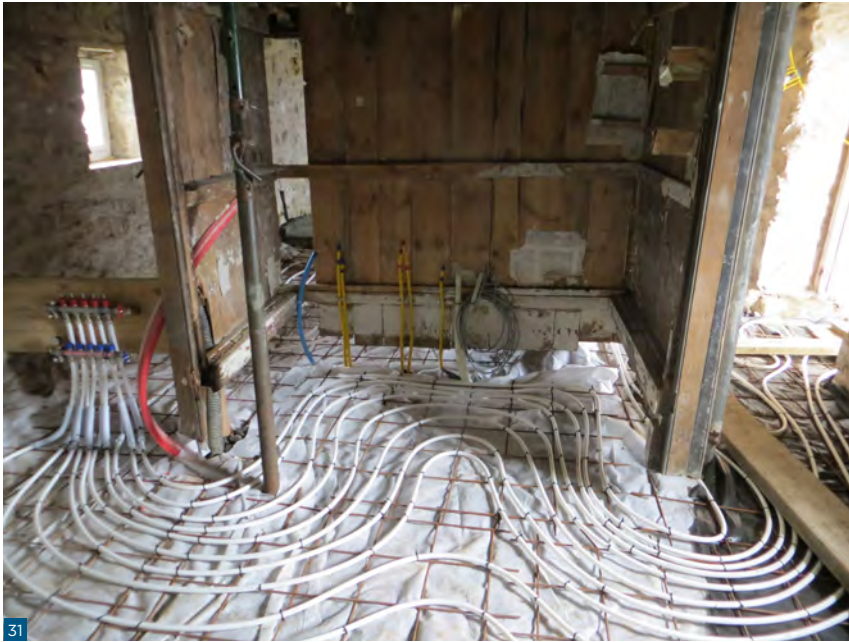
Figure 31: Coils for an underfloor heating system laid on top of a lime concrete floor. The heating is powered by a ground source heat pump. Image © Callum Innes

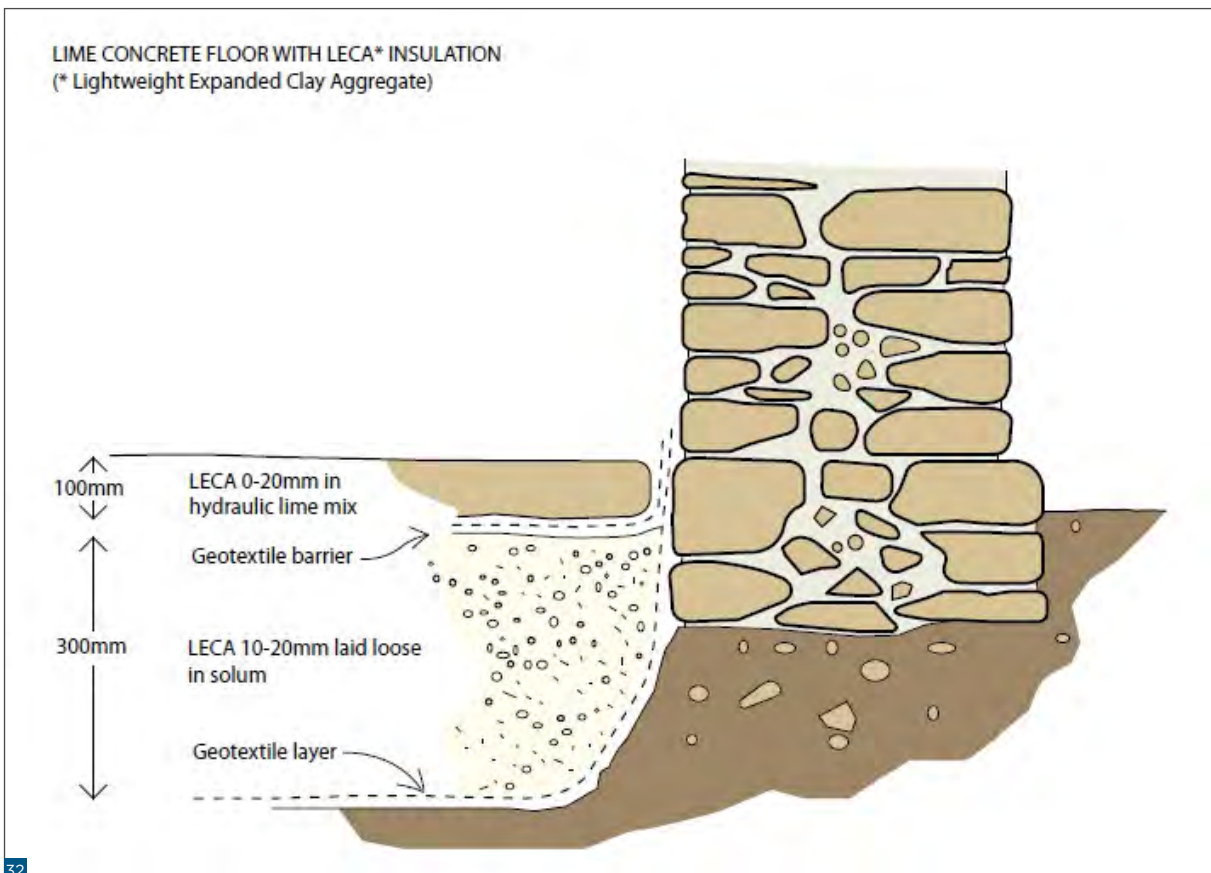
Figure 32: Outline detail for a lime concrete floor.

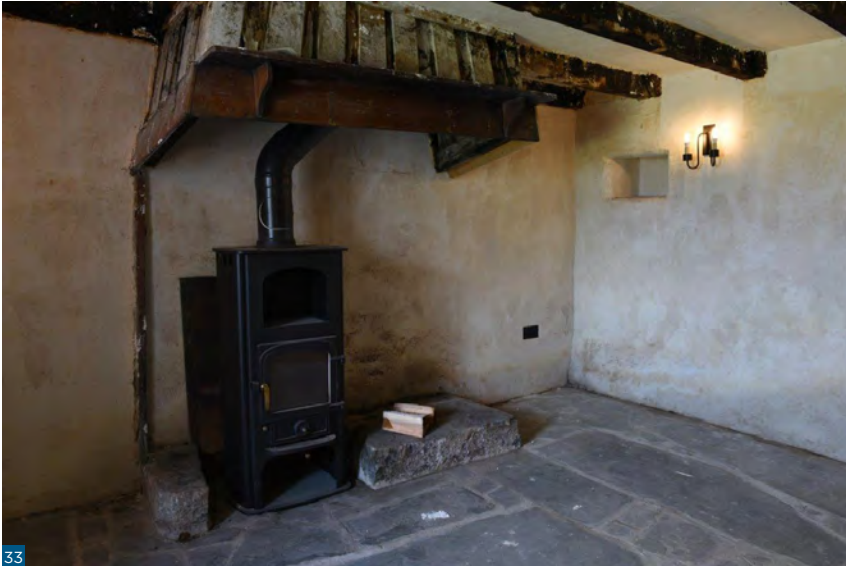
Figure 33: A flagstone floor re-laid on a lime concrete heated slab.

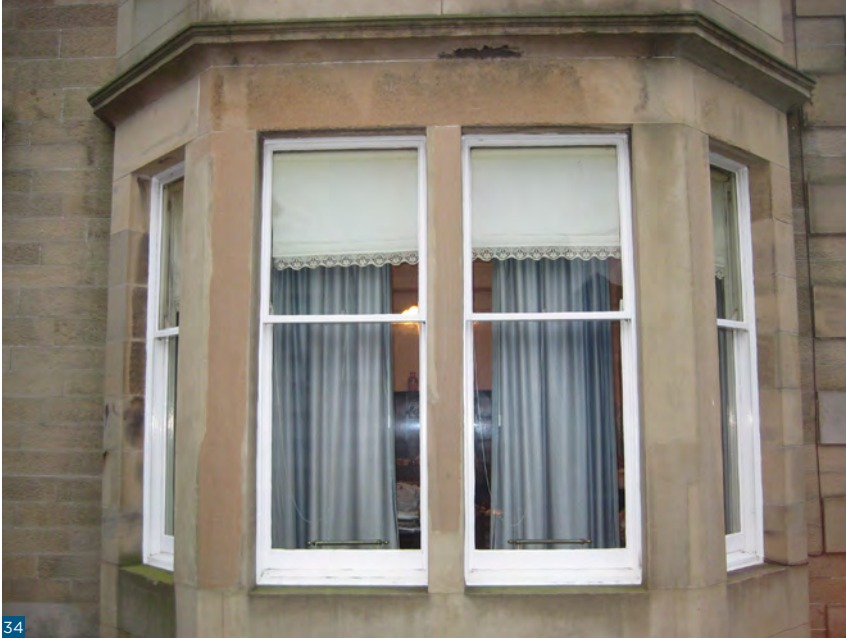
Figure 34: Traditional pattern roller blinds can help reduce heat loss through a window.

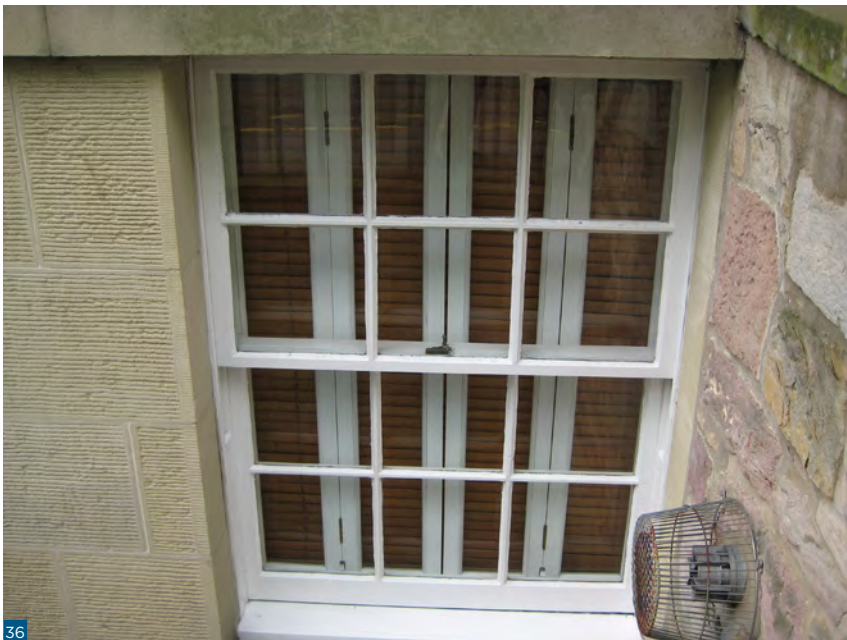
Figure 36: Glazed shutters in use.

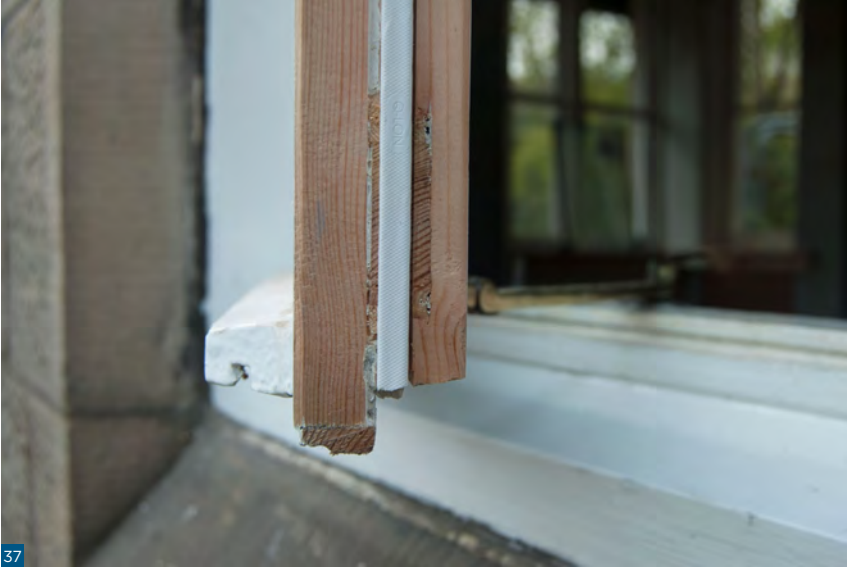
Figure 37: A newly fitted brush strip (white) on a casement window at Holyrood Park Lodge.

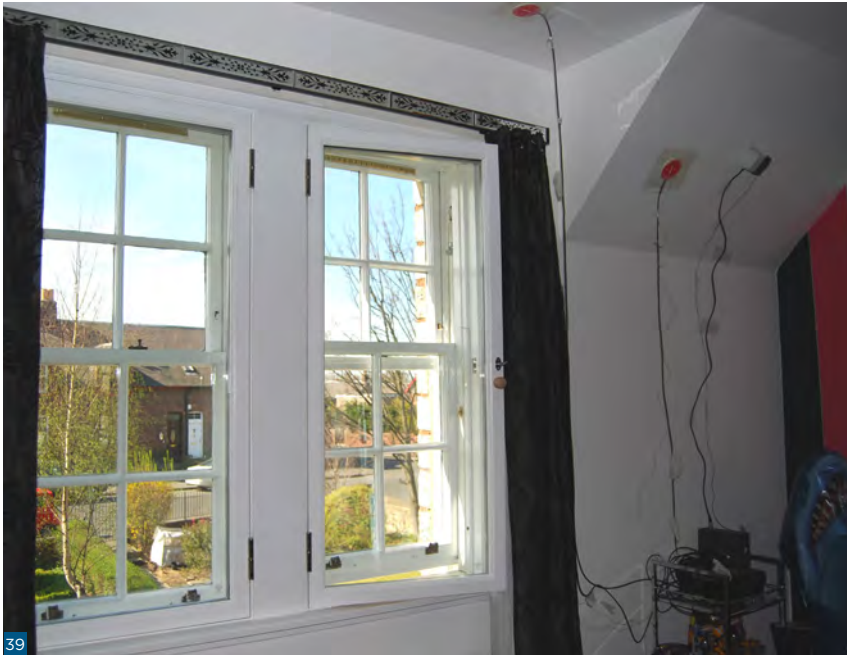
Figure 39: Timber framed secondary glazing in a dormer window.

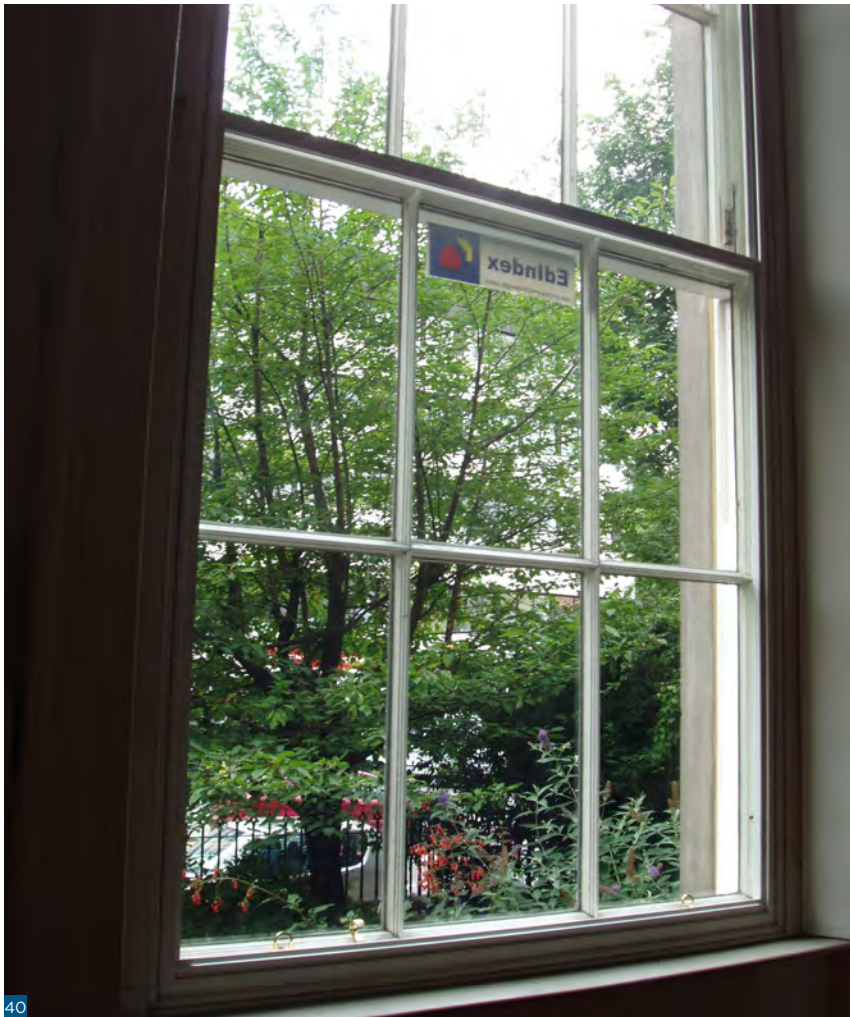
Figure 40: Secondary glazing mounted within the staff beads, allowing the use of shutters.

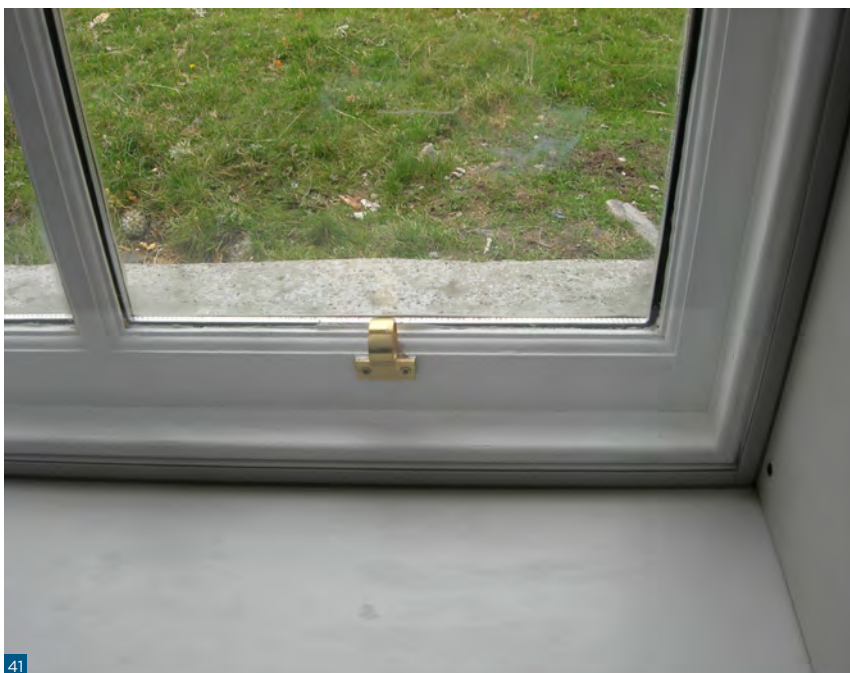
Figure 41: Polycarbonate secondary glazing mounted on a magnetic strip.

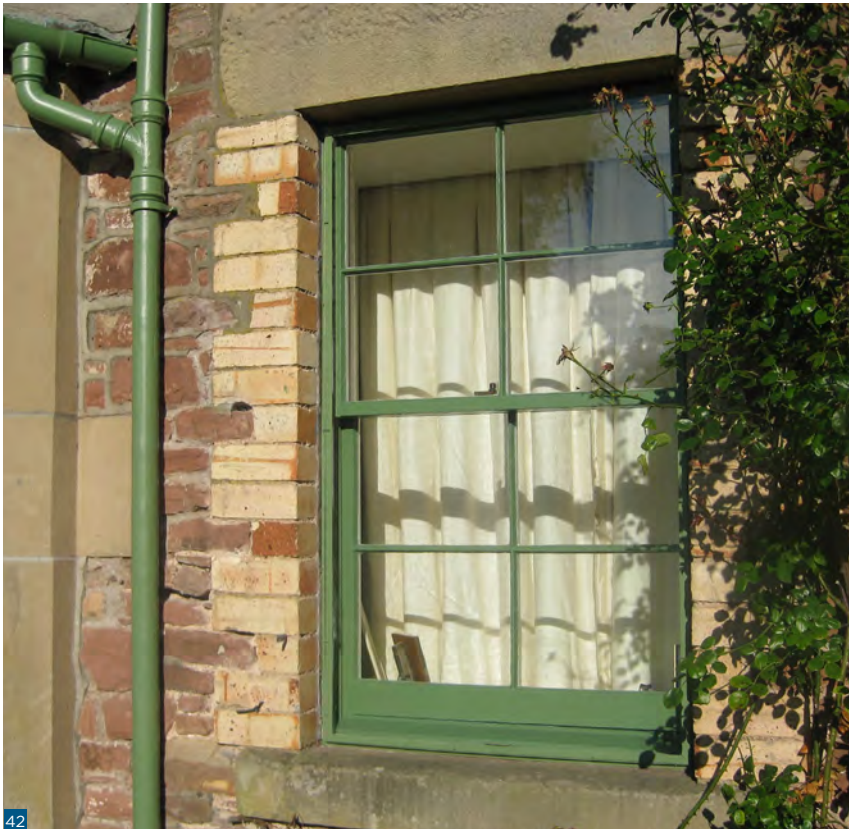
Figure 42: External secondary glazing which gives weathering protection, as well as a degree of thermal improvement.

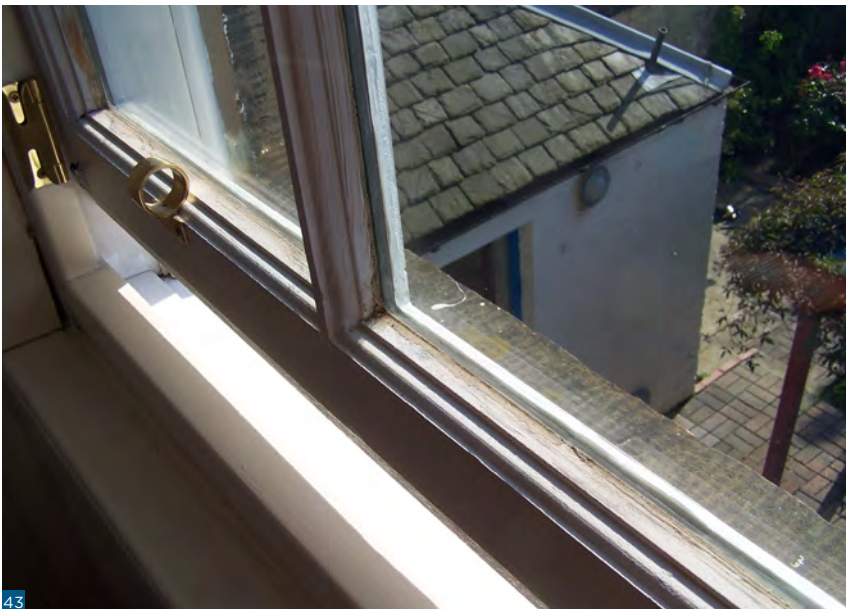
Figure 43: Narrow profile double glazed panes set into an existing window sash. Image © Gordon Barclay

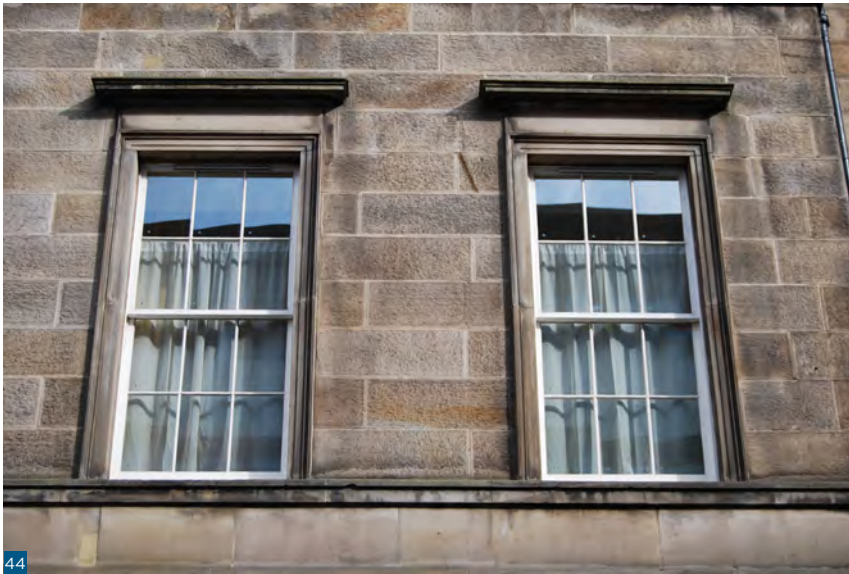
Figure 44: Vacuum panes were trialled at Archibald Place, Edinburgh, in 2009.

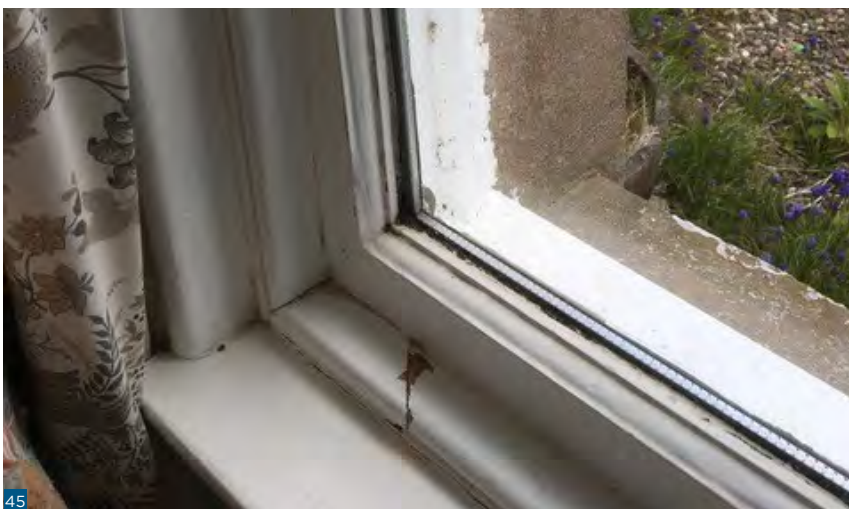
Figure 45: A standard dimension double glazed unit fitted into an existing sash.

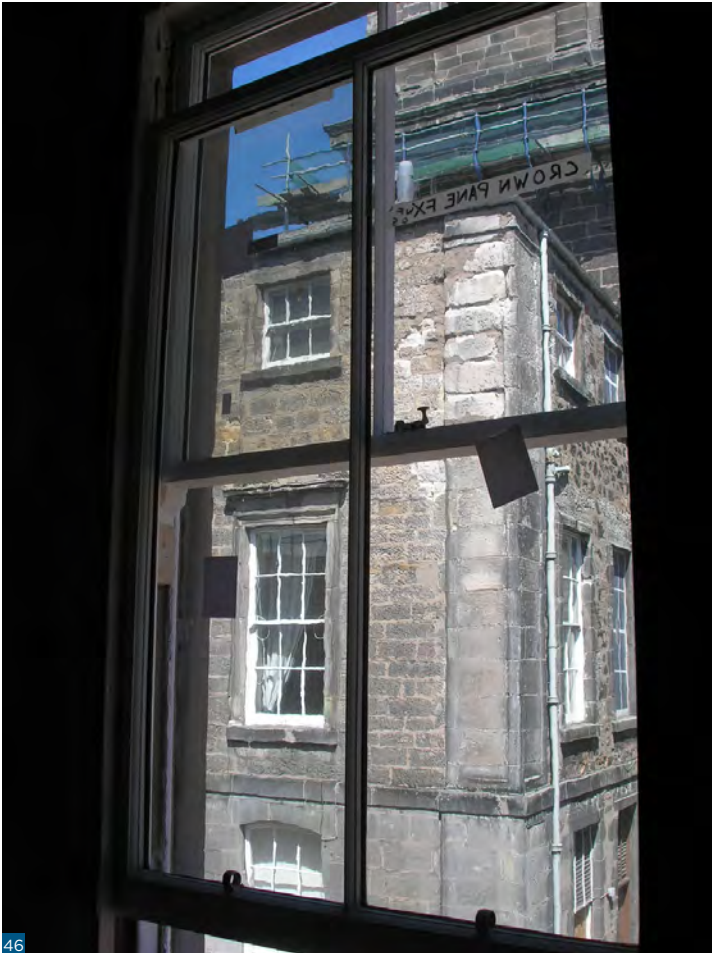
Figure 46: Original glass modified to a form a narrow profile double glazed unit.

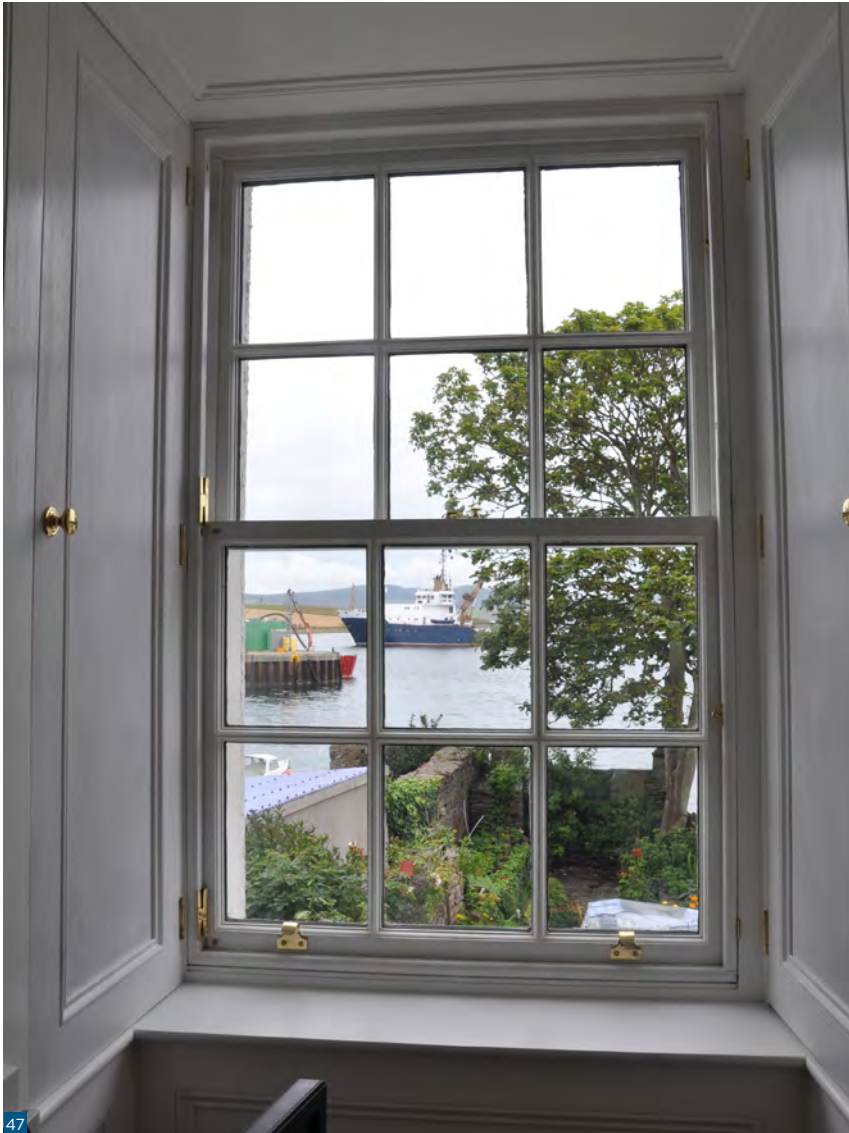
Figure 47: A new sash and case window in a Category B-listed window in Stromness. Note the new working shutters.
