GUIDE TO ENERGY RETROFIT OF TRADITIONAL BUILDINGS

HISTORIC
ENVIRONMENT
SCOTLAND

Historic Environment Scotland Guide to Energy Retrofit of Traditional Buildings © Historic Environment Scotland 2021

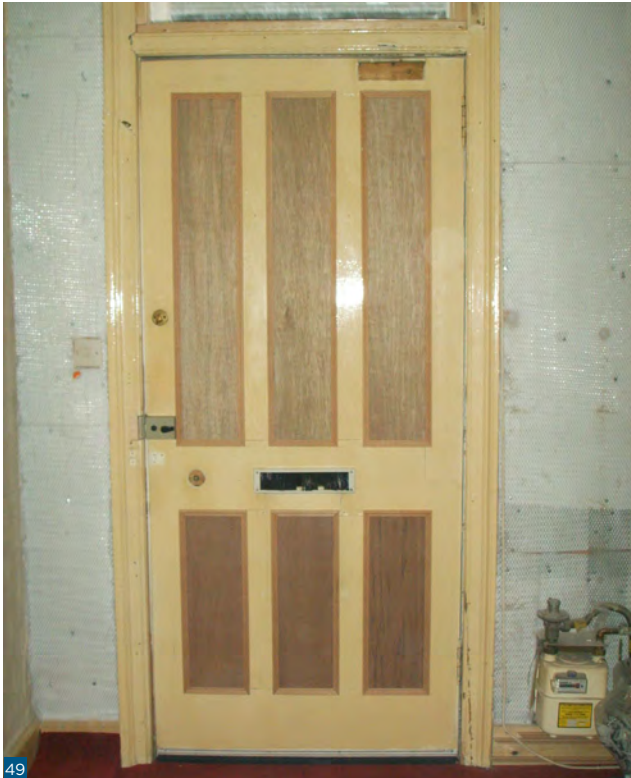
Figure 49: A door in a tenement with the insulation under the new plywood panels prior to painting.

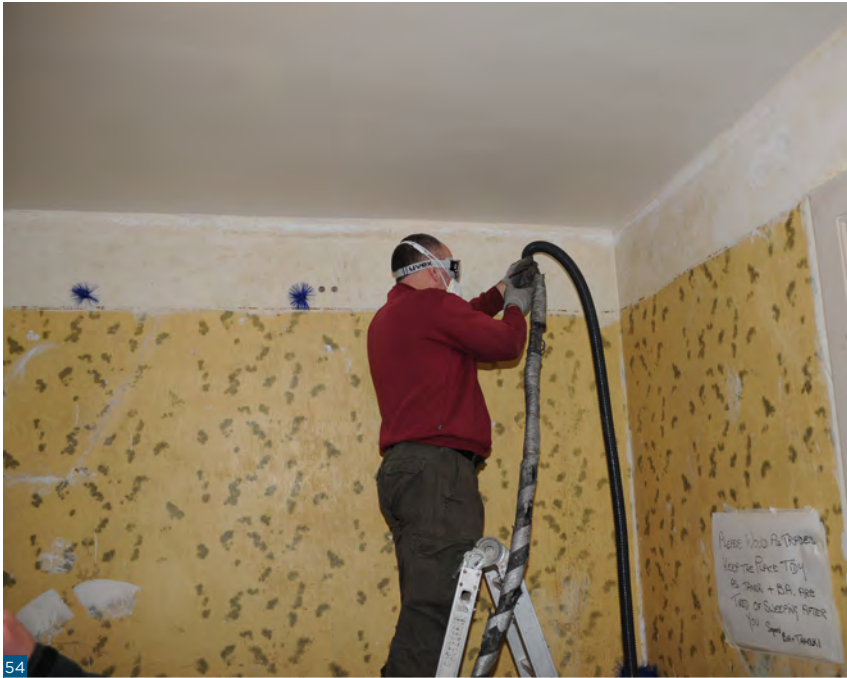
Figure 54: Cellulose fibre being blown behind lath and plaster.

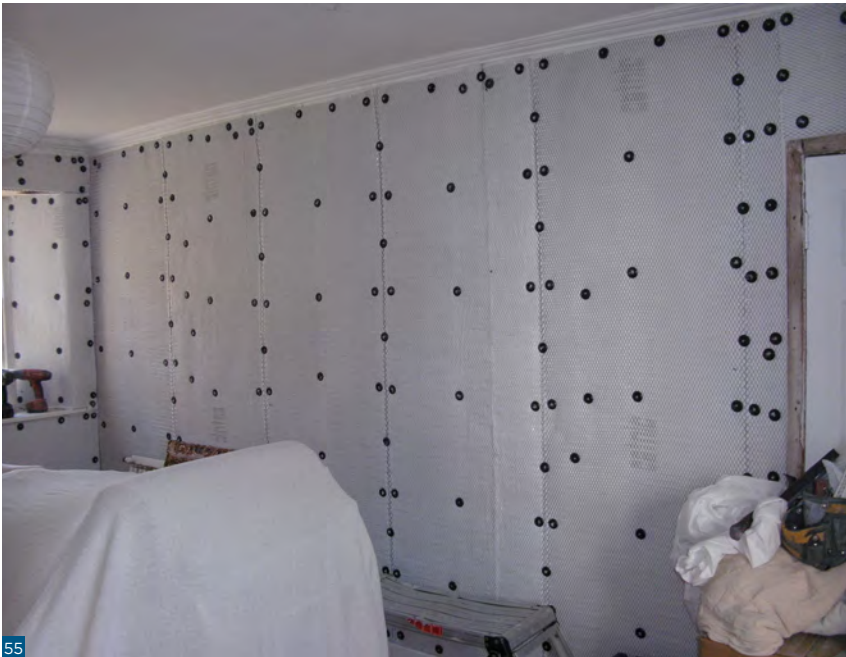
Figure 55: Aerogel blanket applied directly to masonry using thermally decoupled expansion fasteners ([Refurbishment Case Study 3](#)).

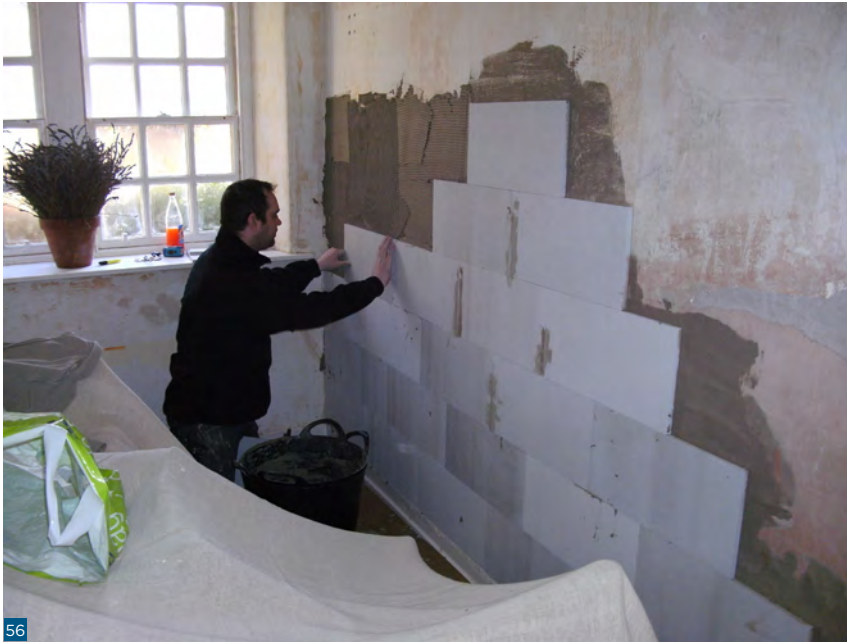
Figure 56: Application of the calcium silicate insulating boards.

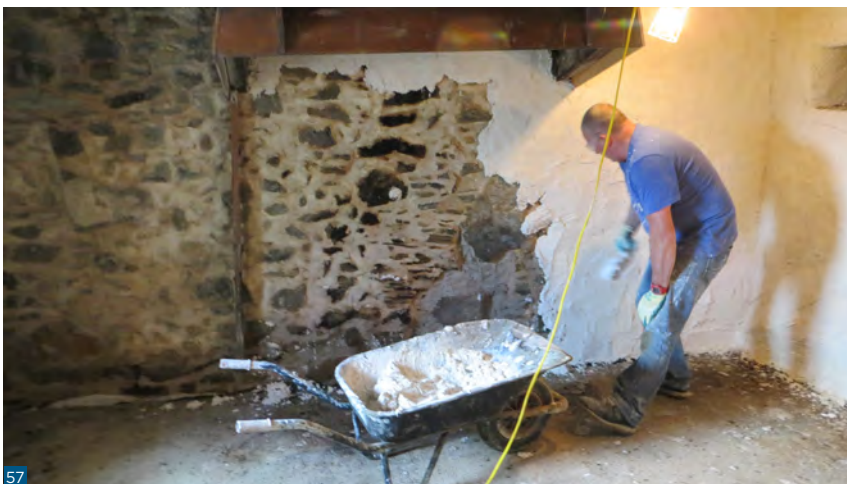
Figure 57: First coat of insulated lime plaster being applied directly to the masonry of the Category A-listed Downie's Cottage, near Braemar. A second coat is applied in much the same way.

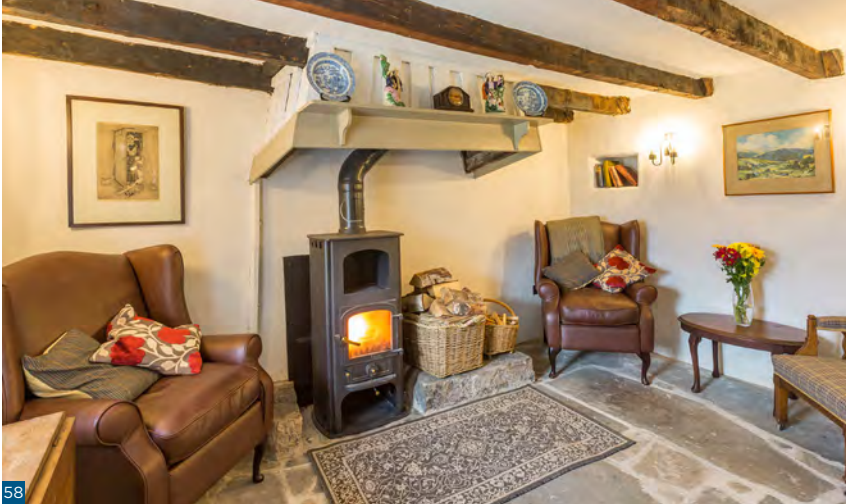
Figure 58: The finished room at Downie's Cottage showing the insulated lime plaster and the re-laid stone flagstones. Image © Callum Innes

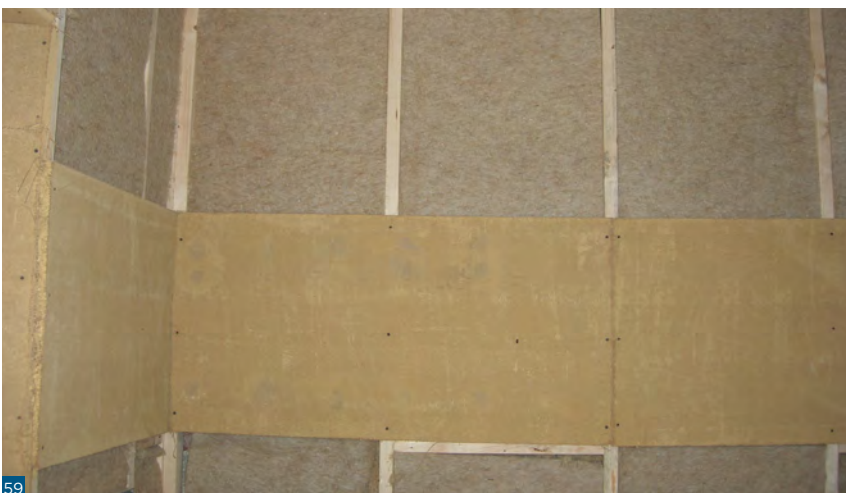
Figure 59: Hemp fibre insulation with clay board.

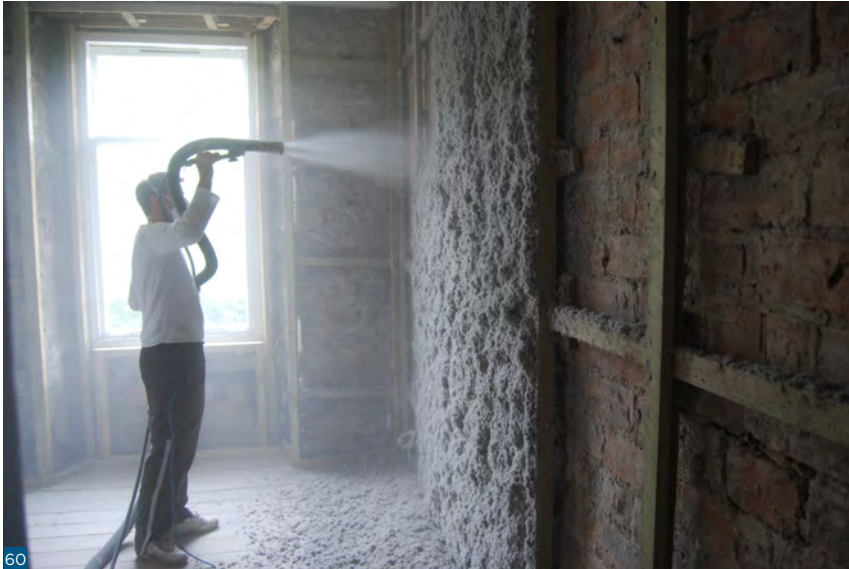
Figure 60: Cellulose insulation being applied damp.

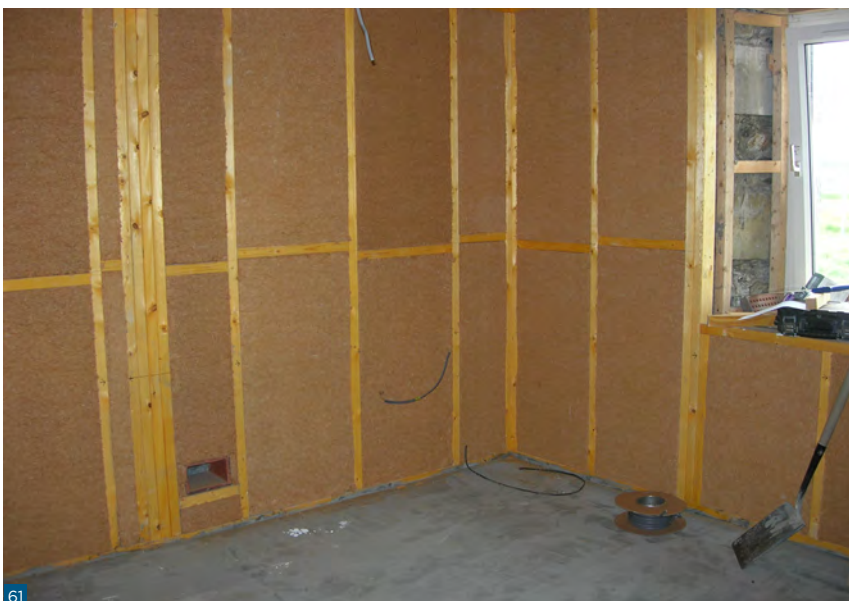
Figure 61: Wood fibre board insulation applied within framing. A U-value of 0.19 was achieved in this example.

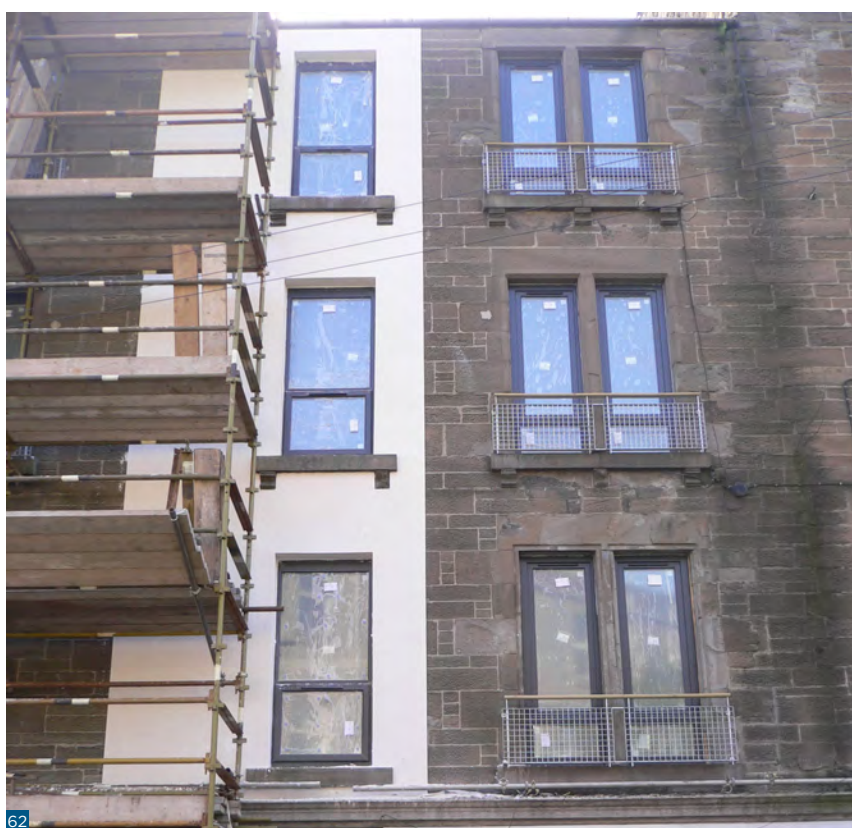
Figure 62: The visual impact of external insulation.

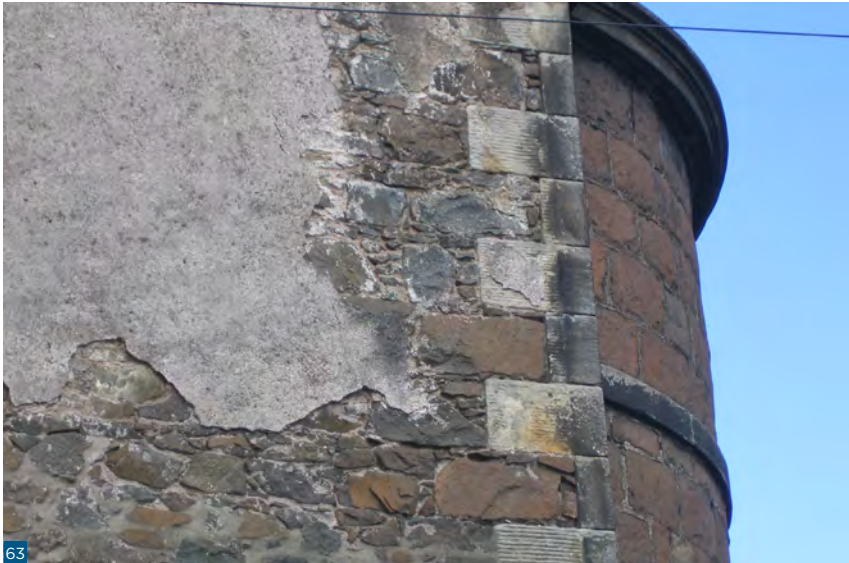
Figure 63: This gable end, which is in need of maintenance and showing the remains of a lime render, is well placed to receive an appropriate form of thin external insulation.

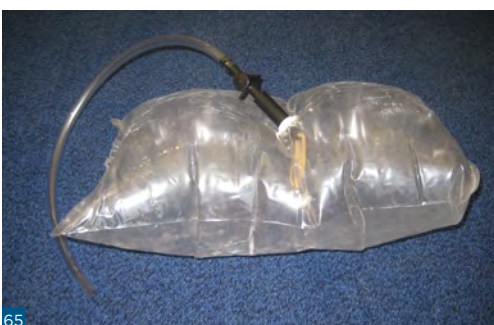
Figure 65: A chimney balloon as used to temporarily close off chimney flues.

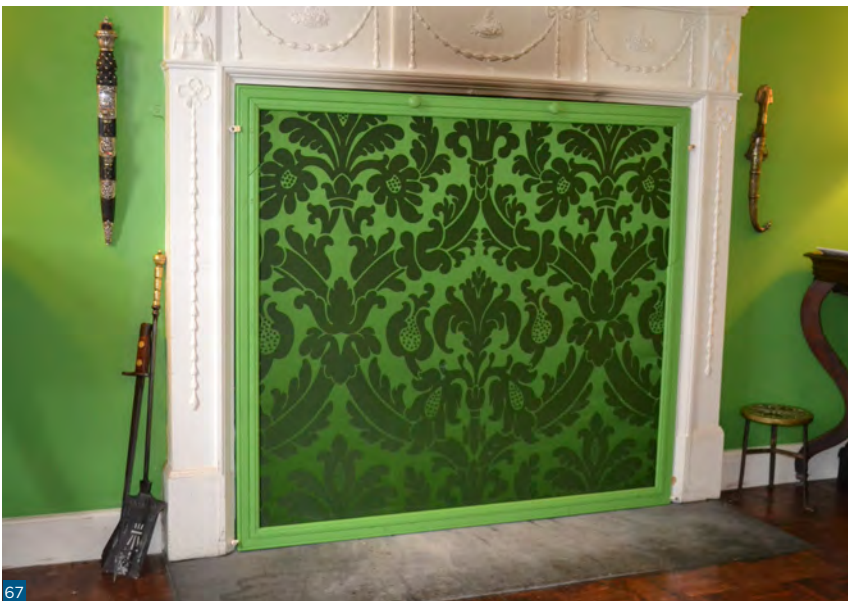
Figure 67: A hearth board used to temporarily close off a fireplace.

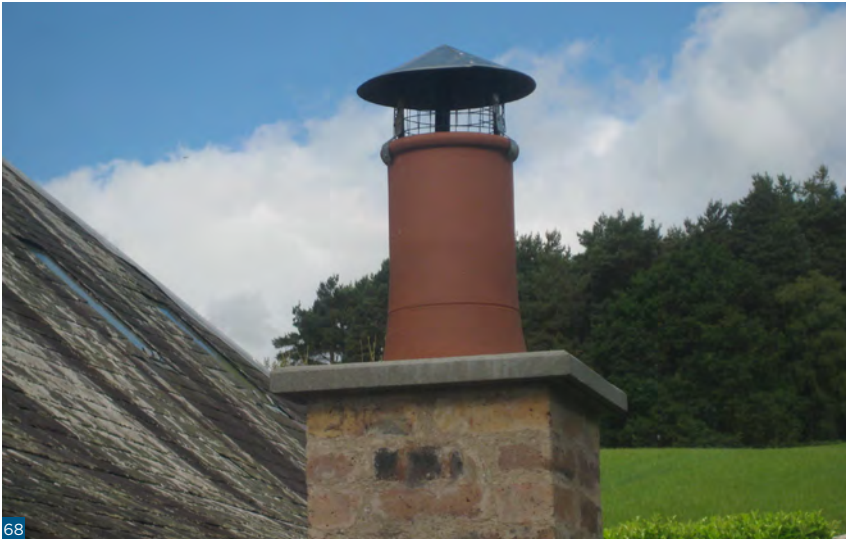
Figure 68: A cowl with mesh keeps a chimney dry, but ventilated and free of birds.

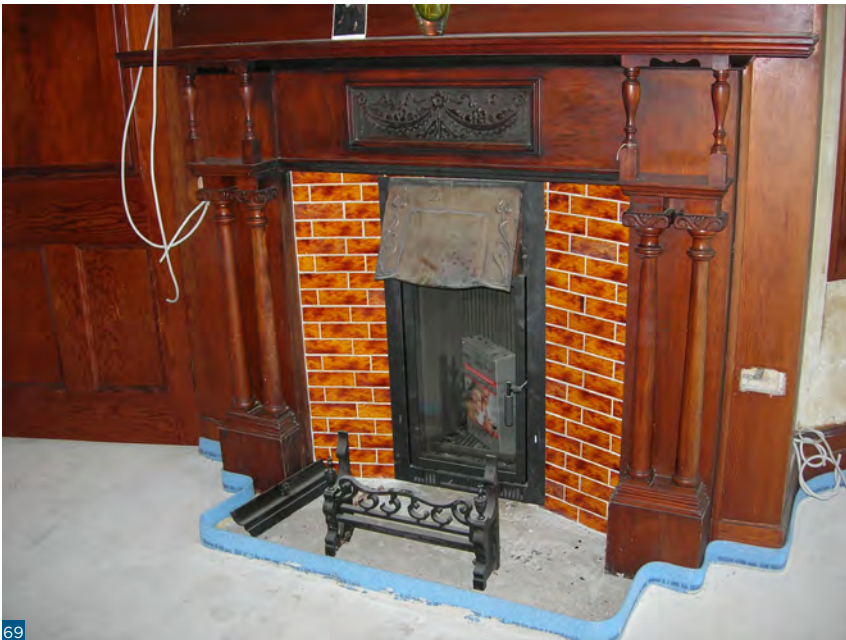
Figure 69: An existing Edwardian cast iron inset retrofitted with a glazed grate for more efficient combustion.
